# Identification of induce draft fan damage using fault tree analysis

Fan damage, Induced draft fan, Fault tree analysis

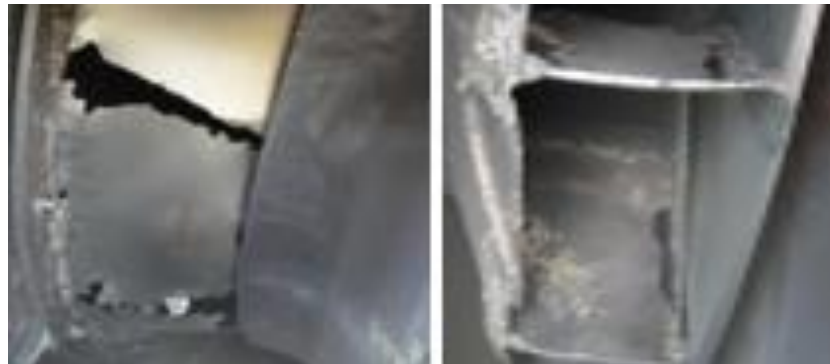
Figure 1. Damage to IDF fan blade and cone

The blade surface on the lip and cone sides will become abrasive if the ESP fails to perform as a dust collector and fly ash containing dust and big particles is drawn in by the IDF. The formation of a perforation on the blade surface causes the IDF to become unbalanced, vibrate more, and lose its capacity to suction coal-burning exhaust gas. Under these circumstances, fly ash pollution of the air will increase and combustion efficiency will drop. The producing unit operations commander will choose to shut down in such circumstances.

Abrasion and perforation on the fan blade and cone by fly ash were confirmed via field observations on operating data and maintenance of the generating unit, documentation of damage and failed IDF components. This was because the ESP was not functioning as a dust collector. In theory, the PLTU NR administration concurs that the ESP's malfunction is the reason for the regular IDF damage. Where the fan blade's abrasive substance ( $\text{Fe}_2\text{O}_3$ ) in the flue gas comes into contact with the blade surface, leading to abrasion and perforation that causes IDF damage. The criteria for coal utilized is lignite, which has a content of  $\text{Fe}_2\text{O}_3$  and falls within the range of chemical composition (4–15%). The grate bar is harmed by an 8.23% ash content rather than the IDF. When the ESP malfunctions, abrasive material ( $\text{Fe}_2\text{O}_3$ ) in the flue gas flows in the direction of the IDF, damaging the blade. It is necessary to revitalize the generating unit's dust collector in order to prevent harm to the IDF and a reduction in the amount of electricity produced the next year. Periodic coal quality testing can be used to analyze this harm and mitigate damage due to coal specifications. Nevertheless, a decision regarding how to handle this issue has not yet been reached. The vendor has offered to repair the current ESP for 6 billion rupiah, or adding a cyclone as a dust collector at an estimated cost of 2.4 billion rupiah is one option

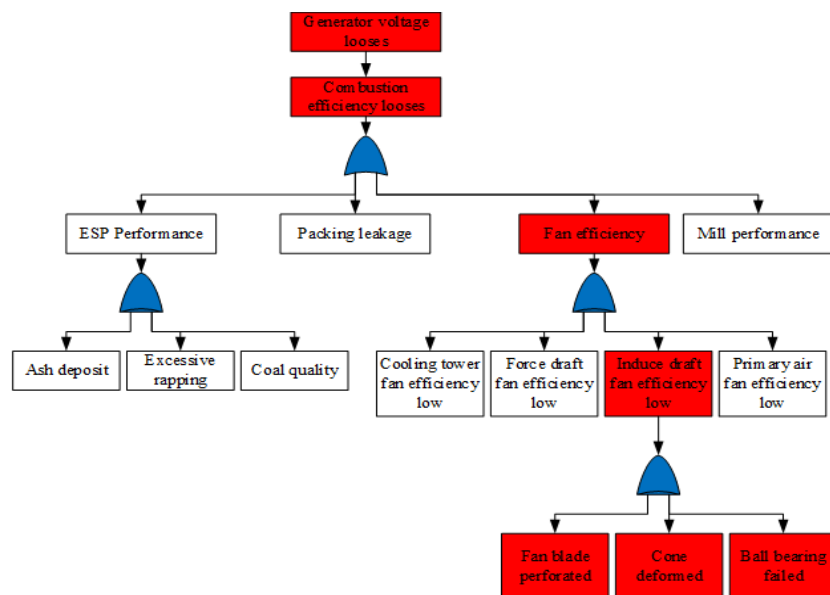
In the meantime, a fault tree analysis was performed on the eight IDF failures in order to understand the sequence of problematic events in the IDF up until the generating unit's shutdown. [Figure 2](#) illustrates how damage to the motor bearings, abrasion and perforation on the fan blade and cone, and IDF efficiency are all automatically reduced [11]. Even though the FDF, PAF, and cooling tower are operating at maximum efficiency, the decline in IDF efficiency causes a decrease in fan efficiency [12]. To ensure that the

Figure 2. Fault tree analysis
