# Identification of induce draft fan damage using fault tree analysis

Steam Power Plants (PLTU) are a type of generator that is widely used by the State Electricity Company (PLN) to meet national electricity needs, the hope of which is to reduce dependence on Diesel Power Plants (PLTD) PT. generating unit. The coal-fired Alamraya Semesta Energy with an installed capacity of 1x15 MW and a production target of 10 MW for utilities and 5 MW for wood processing has an Availability Hour of 82.9% and Unavailability of 17.1% during the period January to December 2013. Unavailability of 17.1% occurred either due to disturbances, inspection and repair of generating unit systems. Based on field findings, the outage occurred due to damage to the brush generator which had been discontinued, requiring fabrication and causing downtime of 32 days and repetitive failure in the IDF (Induced Draft Fan) which was used by the generator maintenance team to remove bottom ash. To determine action to improve the performance of the generating unit, an analysis is carried out of the main causes of IDF damage, as well as the financial losses that arise. Fault tree analysis shows that abrasion and perforation

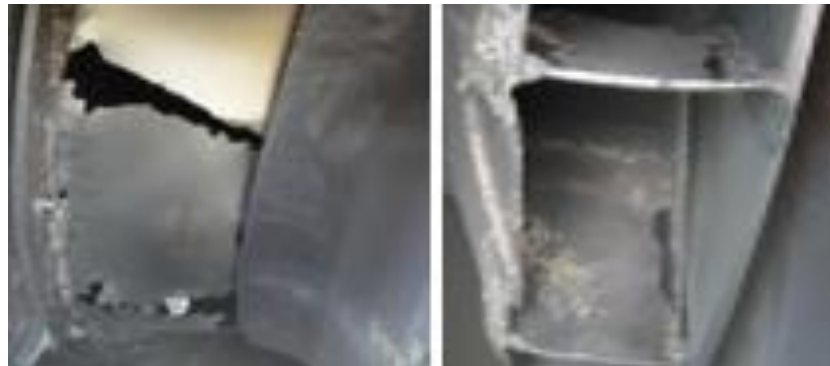
There are five major factors that affect the generating unit's performance, as determined by fault tree analysis, which provides a broad overview of the Nagan Raya PLTU's status. The study concentrated on the factors that led to outages in 2013. Nine of the 80 interruptions resulted in the producing units ceasing to operate. A generator slide ring failure resulted in a single outage that shut down the system for 576 hours. This occurs because fabrication needs to be done and there are no spare parts in the warehouse. In the meantime, since the Nagan Raya PLTU was operational in 2011, this damage to the slip ring is the first. The type of damage to the fan blade and cone is depicted in [Figure 1](#).

Figure 1. Damage to IDF fan blade and cone

The blade surface on the lip and cone sides will become abrasive if the ESP fails to perform as a dust collector and fly ash containing dust and big particles is drawn in by the IDF. The formation of a perforation on the blade surface causes the IDF to become unbalanced, vibrate more, and lose its capacity to suction coal-burning exhaust gas. Under these circumstances, fly ash pollution of the air will increase and combustion efficiency will drop. The producing unit operations commander will choose to shut down in such circumstances.

Abrasion and perforation on the fan blade and cone by fly ash were confirmed via field observations on operating data and maintenance of the generating unit, documentation of damage and failed IDF components. This was because the ESP was not functioning as a dust collector. In theory, the PLTU NR administration concurs that the ESP's malfunction is the reason for the regular IDF damage. Where the fan blade's abrasive substance ( $\text{Fe}_2\text{O}_3$ ) in the flue gas comes into contact with the blade surface, leading to abrasion and perforation that causes IDF damage. The criteria for coal utilized is lignite, which has a content of  $\text{Fe}_2\text{O}_3$  and falls within the range of chemical composition (4–15%). The grate bar is harmed by an 8.23% ash content rather than the IDF. When the ESP malfunctions, abrasive material ( $\text{Fe}_2\text{O}_3$ ) in the flue gas flows in the direction of the IDF, damaging the blade. It is necessary to revitalize the generating unit's dust collector in order to prevent harm to the IDF and a reduction in the amount of electricity produced the next year. Periodic coal quality testing can be used to analyze this harm and mitigate damage due to coal specifications. Nevertheless, a decision regarding how to handle this issue has not yet been reached. The vendor has offered to repair the current ESP for 6 billion rupiah, or adding a cyclone as a dust collector at an estimated cost of 2.4 billion rupiah is one option

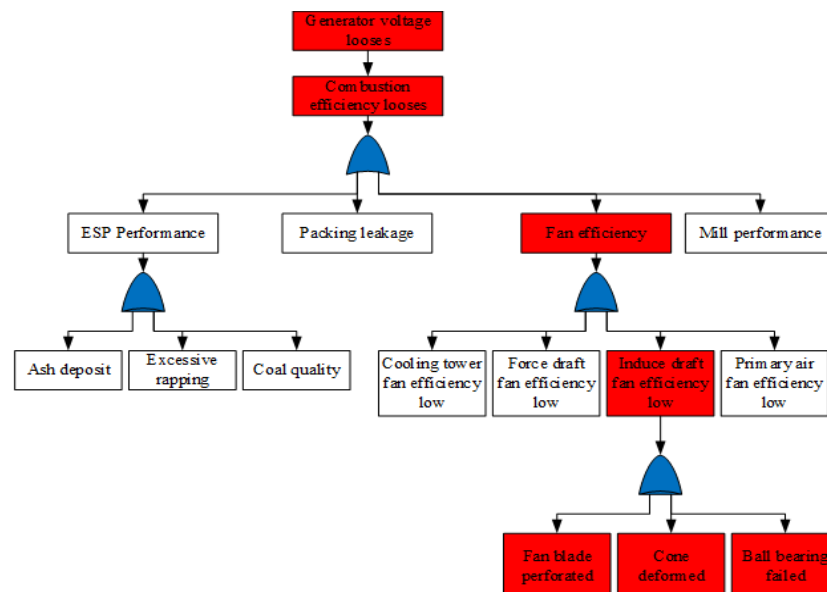
In the meantime, a fault tree analysis was performed on the eight IDF failures in order to understand the sequence of problematic events in the IDF up until the generating unit's shutdown. [Figure 2](#) illustrates how damage to the motor bearings, abrasion and perforation on the fan blade and cone, and IDF efficiency are all automatically reduced [\[11\]](#). Even though the FDF, PAF, and cooling tower are operating at maximum efficiency, the decline in IDF efficiency causes a decrease in fan efficiency [\[12\]](#). To ensure that the

Figure 2. Fault tree analysis

The IDF damage cycle occurred eight times, resulting in 911 hours of downtime or 61% of the total downtime. This does not include the eight hours required to start up the generating unit each time a shutdown occurs until the PLTU is able to export electricity to customers. Additionally, the short-term or temporary repair expenses came to Rp. 775,215,870.
